# BELZONA REPAIRS AND WATERPROOFS OFFSHORE ROOF

**Industry:** Oil & Gas  
**Application:** RPA-Roof Problem Areas  
**Substrate:** Steel  
**Products:** \* Belzona® 1121 (Super XL Metal) ,  
\* Belzona® 3111 (Flexible Membrane System) ,

**Customer Location:** Oil Producer, Gulf of Mexico.  
**Application Date:** May 2010

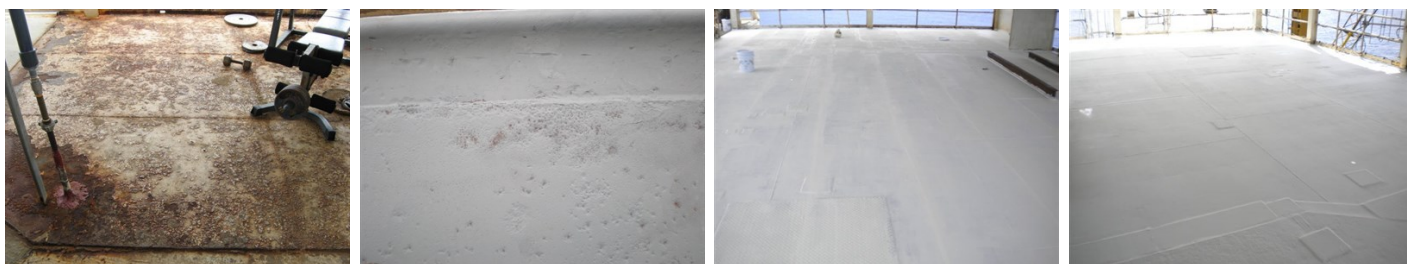
## Photograph Descriptions

Customer seeking roof repair and installation of waterproofing system without disrupting oil and gas production. Metal roof had severe corrosion resulting in thin wall and some holes through the plates.

- \* Roof showing severe corrosion ,
- \* Roof after grit blasting ,
- \* Roof after repairs and first coat Belzona 3111 ,
- \* Roof after completion ,

Application was carried out in accordance with Belzona System Leaflets RPA-1, RPA-6 and TCC-1. Belzona 1121 was used to bond doubler plates over thinned and holed areas before applying a fully reinforced Belzona 3111 System over the entire area.
