# COLD PLATE BONDING WITH BELZONA RESTORES SUMP TANK

Customer Location: Offshore Production Platform, Gulf of Mexico

Application: GSS-Gaskets, Seals and Shims

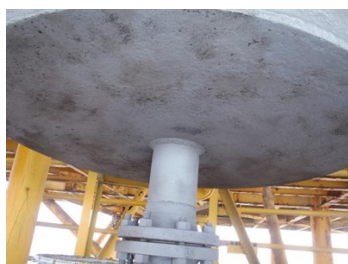
Exposure to the elements and oil & gas process systems caused severe corrosion to exterior of sump tank bottom. Damage resulted in thin wall and through hole areas.

\* 1. Corroded tank bottom 2.Sump bottom after blasting 3.New bottom jacked into place 4. Bonding completed ,
