COLD PLATE BONDING WITH BELZONA RESTORES SUMP TANK

ID: 1590

Customer Location: Offshore Production Platform, Gulf of Mexico

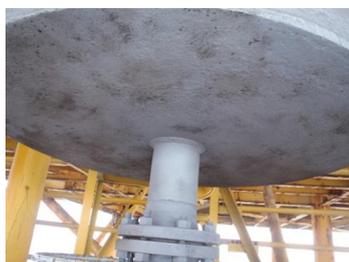
Exposure to the elements and oil & gas process systems caused severe corrosion to exterior of sump tank bottom. Damage resulted in thin wall and through hole areas.

* 1. Corroded tank bottom 2.Sump bottom after blasting 3.New bottom jacked into place 4. Bonding completed ,

Application was carried out in accordance with Belzona Know-How System Leaflet GSS-10. Belzona 1121 was used to cold bond pre-fabricated replacement bottom on the tank.
