# BELZONA HELPS PROTECT OFFSHORE PLATFORM LEGS AT WATERLINE

Customer Location: Major Oil & Gas Producer, Gulf of Mexico

Application: SOS-Ships and Offshore Structures

Application Date: May, 2010

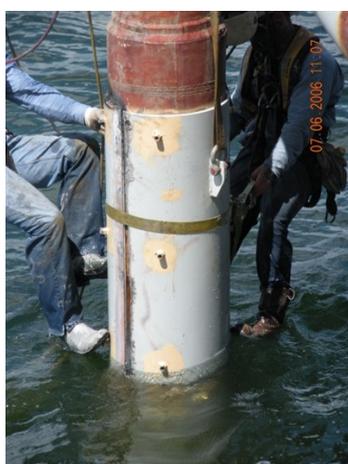
Due to corrosion and impact damage platform legs were at risk of losing structural integrity. Client wanted to terminate damage to avoid further deterioration. Customer had welded top and sides of halfwrap without welding bottom, due to water/wave action. Corrosion had actually accelerated between the leg and halfwrap.

- \* Platform leg showing typical damage ,
- \* Halfwrap being installed ,
- \* Application of Belzona 1161 to seal bottom seam ,
- \* Injection of Belzona 5831 to fill cavity between leg and halfwrap ,

Platform legs damaged by corrosion and impact from service/crew boats at the waterline.

Application was carried out in accordance with modified Belzona Know-How System Leaflet SOS-8. Belzona 1161 was used to seal

the bottom of split shells, and Belzona 5831 was then injected to fill cavity between platform leg and steel wrap.
