BELZONA HELPS PROTECT OFFSHORE PLATFORM LEGS AT WATERLINE

Customer Location: Major Oil & Gas Producer, Gulf of Mexico

Application: SOS-Ships and Offshore Structures

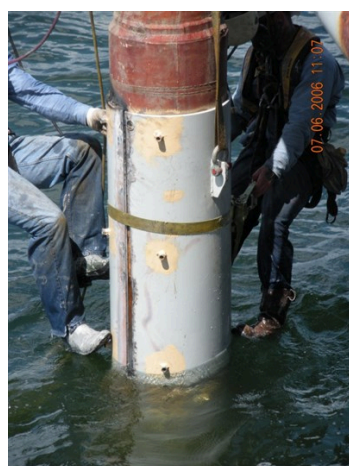
Due to corrosion and impact damage platform legs were at risk of losing structural integrity. Client wanted to terminate damage to avoid further deterioration. Customer had welded top and sides of halfwrap without welding bottom, due to water/wave action. Corrosion had actually accelerated between the leg and halfwrap.

- * Platform leg showing typical damage ,
- * Halfwrap being installed ,
- * Application of Belzona 1161 to seal bottom seam ,
- * Injection of Belzona 5831 to fill cavity between leg and halfwrap ,

Platform legs damaged by corrosion and impact from service/crew boats at the waterline.

Application was carried out in accordance with modified Belzona Know-How System Leaflet SOS-8. Belzona 1161 was used to seal

the bottom of split shells, and Belzona 5831 was then injected to fill cavity between platform leg and steel wrap.
