Belzona Repairs Trip Hazards at Cider Factory

ID: 1593

Customer Location: Cider Manufacturer, UK
Application Date: December 2008

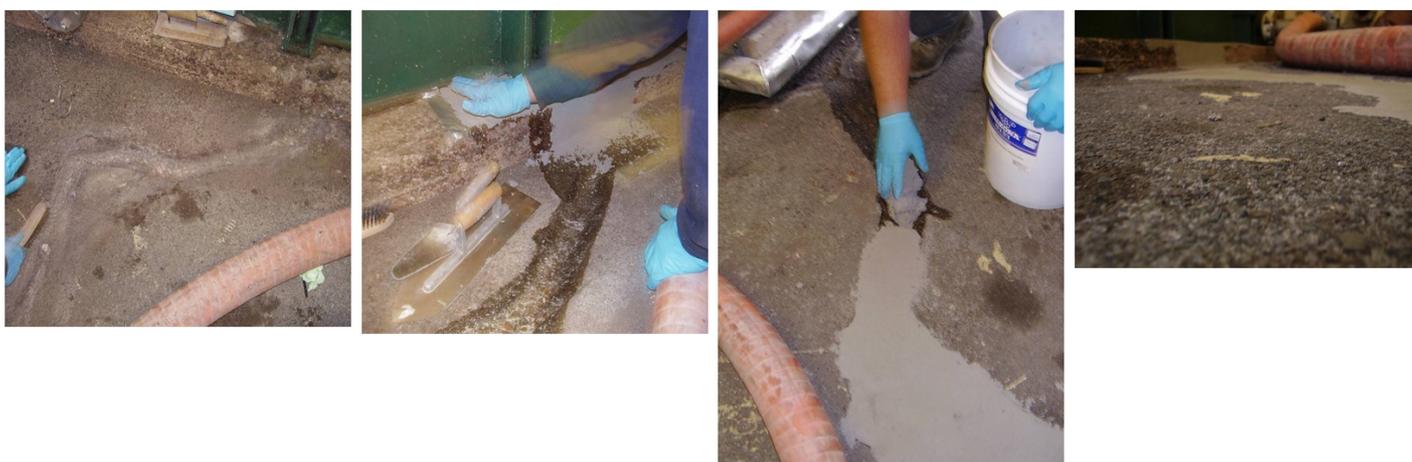
Photograph Descriptions

There are access lids at the base of the tank which are held in place with bolts and secured by a gasket to the base of the lid. However, these areas can be prone to leaking as the aggressive cider juice drips and eats away at the gasket and then attacks the concrete floor at the base of the tank, as you can see from the pictures. Eventually, this creates a gulley which can be a serious trip hazard.

- * The grooves in the floor ,
- * Applying the Belzona® 4131 by hand ,
- * Filling in the gaps by hand ,
- * The old and new floor, viewed at ground level ,

The areas requiring repair were washed down. As per the IFU once dry the areas were coated with Belzona® 4911 followed by Belzona® 4131. We discovered that the process worked best when applied by (gloved) hand whilst holding the trowel against the

concrete edge and sliding the trowel away once the Belzona® 4131 was in the void.

After a first inspection over a month later, the surrounding area was discolouring and graining but the reclaimed areas were standing up well to exposure to the raw cider. As a result, the client now wishes to coat the whole area once the application has proved itself, as well as the other eight 'planetary suites.
