# BELZONA UPGRADES FLOOR IN FOOD PREPARATION AREA

ID: 1596

Customer Location: School, UK  
Application Date: October 2010

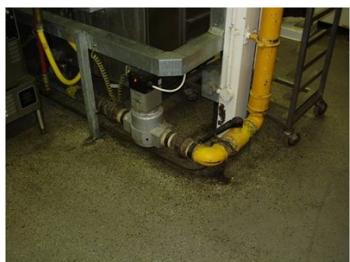
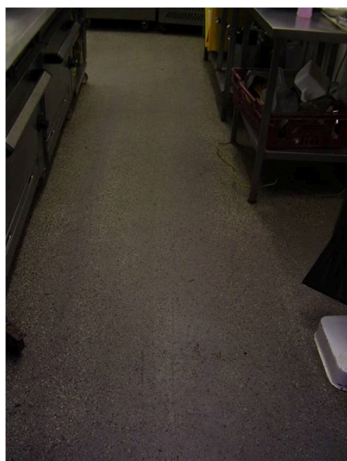
*The floor was slippery creating a health and safety issue. In addition the concrete was being damaged around drains.*

- \* Floor Problem Area ,
- \* Floor Problem Area ,
- \* Completed Floor Application ,
- \* Completed Floor Application ,

The application was carried out in accordance with Belzona Know-How System Leaflet FPA-3. The concrete was abraded to remove the existing coating before applying the 2 coat Belzona® 5231 system by roller.
