BELZONA UPGRADES FLOOR IN FOOD PREPARATION AREA

ID: 1596

Customer Location: School, UK
Application Date: October 2010

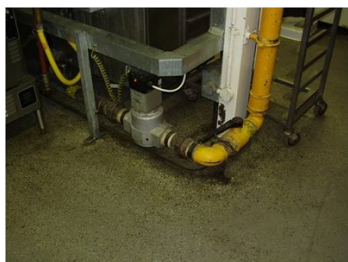
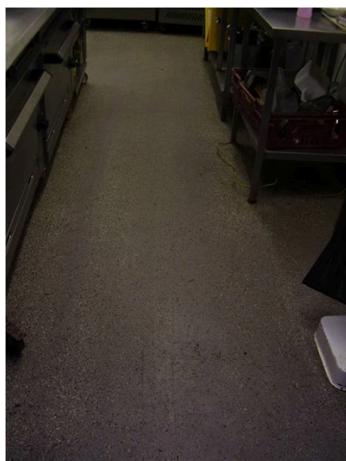
The floor was slippery creating a health and safety issue. In addition the concrete was being damaged around drains.

- * Floor Problem Area ,
- * Floor Problem Area ,
- * Completed Floor Application ,
- * Completed Floor Application ,

The application was carried out in accordance with Belzona Know-How System Leaflet FPA-3. The concrete was abraded to remove the existing coating before applying the 2 coat Belzona® 5231 system by roller.
