# BELZONA REINFORCES TANK AT STEEL MILL

ID: 1599

Customer Location: Steel Mill, North-Rhine Westphalia,  
Germany

Corrosion of safety immersion tanks in the coke manufacturing plant

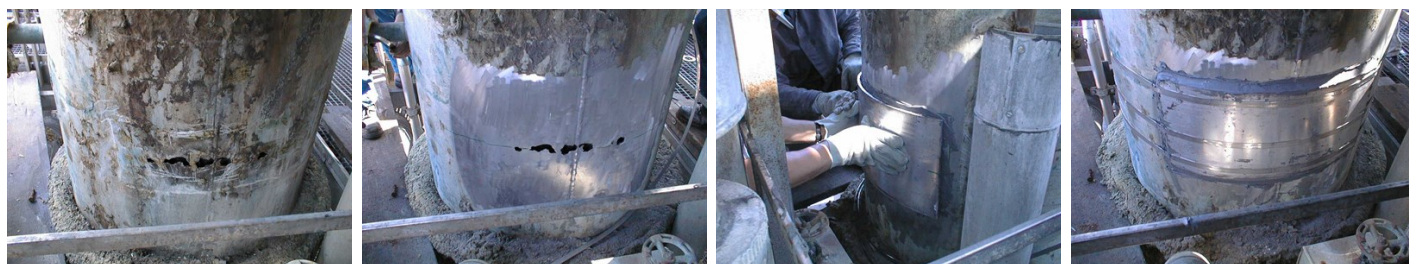
These tanks were damaged around the connection and the walls through the chemical attack of the contained medium (coke gas in water) and local steam. The temperatures ranged from 50°C to 104°C

- \* The corroded tank ,
- \* Preparation ,
- \* Fitting the plate ,
- \* Finished application ,

Application was carried out in accordance with Belzona Know-How System leaflet TCC-1. A formed section was made up. Belzona<sup>®</sup> 1111 was then applied to both surfaces and then assembled, using metal strapping to hold in place whilst the Belzona cured. Excess material was used as a fillet around the plate. After completion of cure the straps were removed.

The Belzona repair provided a stress free repair to the corroded areas. In addition to plate bonding a corroded stub pipe was also repaired (see KHIA Vol xxxxxxxx)
