# BELZONA TAIL SHAFT PROTECTION

ID: 16

Industry: Oil & Gas  
Application: SOS-Ships and Offshore Structures

Customer Location: Offshore Oil Company - China  
Application Date: March 1998

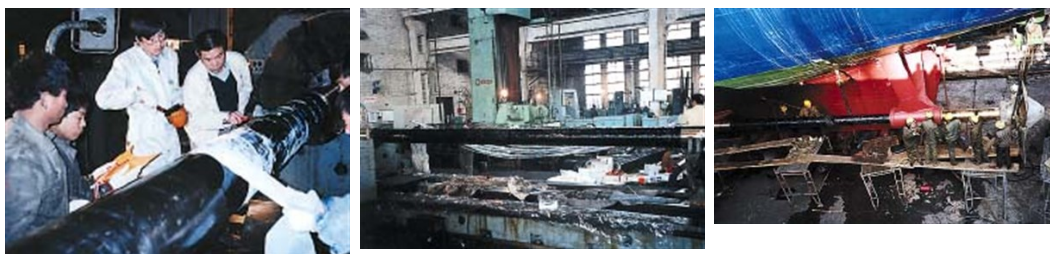
## Photograph Descriptions

- \* Application in progress. ,
- \* Shaft is coated. ,
- \* Tail shaft being installed. ,

Due to the change of bronze bush and corrosion from sea water a new protective coating was required on the shaft. Since the shafts were very long, flex vibration was a concern. A flexible protective system was used.

(Two) 13 meters long and 0.32 meters wide tail shafts on an exploration boat.

Application was carried out in accordance with a modified version of Belzona Know-How Leaflet SOS-6.
