BELZONA TAIL SHAFT PROTECTION

Industry: Oil & Gas
Application: SOS-Ships and Offshore Structures

Customer Location: Offshore Oil Company - China
Application Date: March 1998

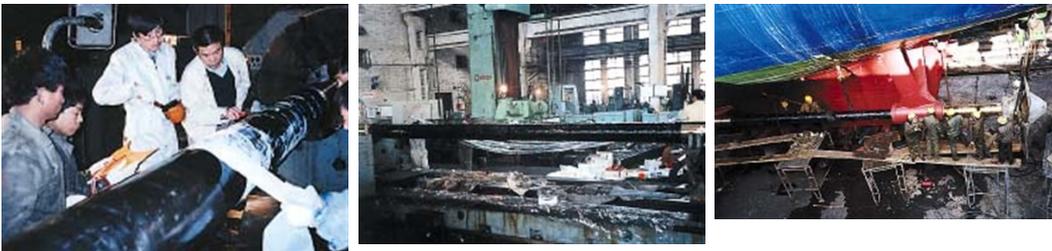
Due to the change of bronze bush and corrosion from sea water a new protective coating was required on the shaft. Since the shafts were very long, flex vibration was a concern. A flexible protective system was used.

- * Application in progress. ,
- * Shaft is coated. ,
- * Tail shaft being installed. ,

(Two) 13 meters long and 0.32 meters wide tail shafts on an exploration boat.

Application was carried out in accordance with a modified version of Belzona Know-How Leaflet SOS-6.
