BELZONA SAVES AGRICULTURAL CHEMICAL COMPANY \$3 MILLION

Application: TCC-Tanks and Chemical Containment Areas

Substrate: Stainless steel vacuum piping, carbon steel drum

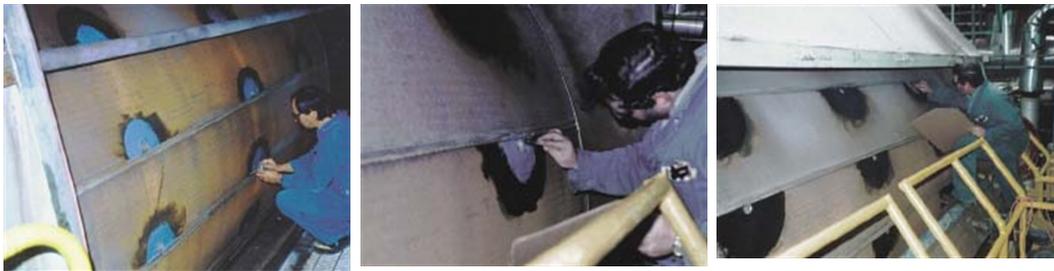
Photograph Descriptions

Leaks developed at the welds joining the vacuum lines to the face of the drum. The inside diameter of the drum was so deteriorated that there was some flexing at the drum face.

- * Belzona® 1221 around pipe, Belzona® 2311 on the drum around the Super E Metal patch ,
- * Beginning Belzona® 2311 patches ,
- * Completing Belzona® 2311 over Belzona® 1221 ,

After six weeks, the customer decided to check the repairs, believing that they were probably beginning to fail. Six repair areas were ground off, and no problems were observed. They were re-done as before, and the drum returned to service, saving the company over \$3 million.
