BELZONA REPAIRS STUB PIPE AT STEEL MILL

Corrosion of safety immersion tanks in the coke manufacturing plant

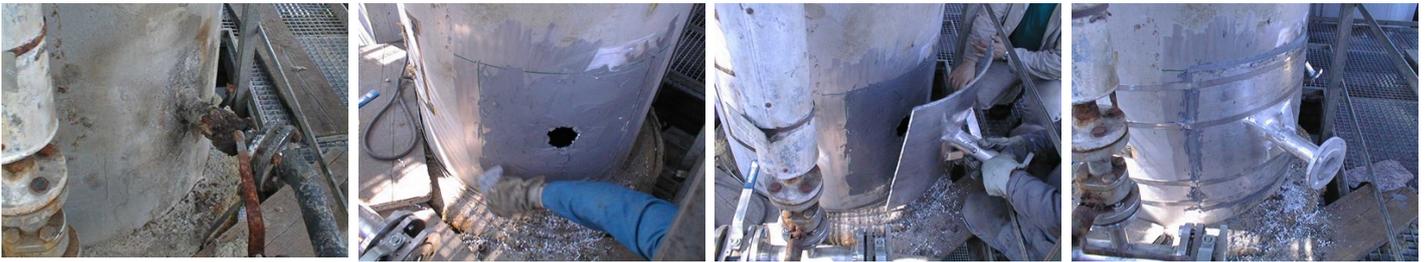
Photograph Descriptions

These safety immersion tanks were damaged around the connection and the walls through the chemical attack of the contained medium coke gas and water) and local steam. The temperatures ranged from 50°C to 104°C

- * The corroded tank and pipe ,
- * Application of Belzona[®] 1111 ,
- * Fitting the plate ,
- * Finished application ,

Application was carried out in accordance with a modified version of Belzona Know-How System Leaflet TCC-1. A stub pipe welded to a formed plate was fabricated. Belzona[®] 1111 was applied to both surfaces and then assembled. Metal strapping was used to hold it in place whilst the Belzona cured. Excess material was used as a fillet around the plate. After completion of cure the straps were removed.
