# BELZONA REPAIR MAKES A RIVETTING STORY

ID: 1602

Customer Location: Oil Blender, Duisburg, North-Rhine Westphalia, Germany

Storage tank for petroleum fuels

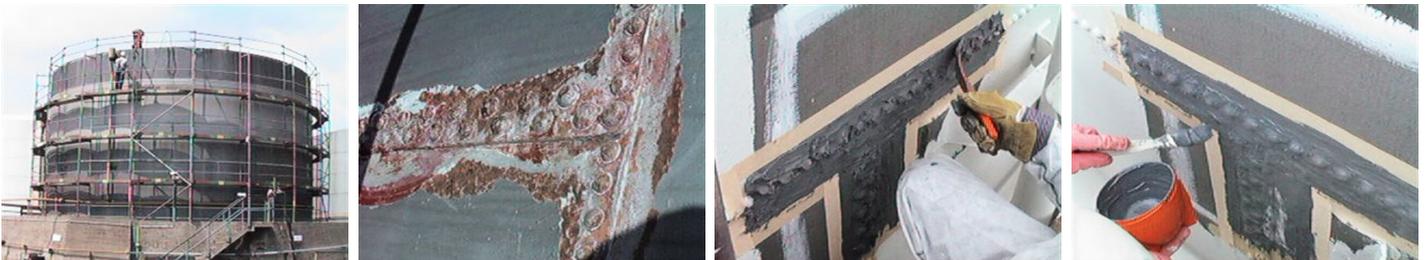
Some of the riveted seams were leaking through blistering of the anti corrosive paint. If the blisters were pierced then the fuel oil would leak out. The tank was 14m diameter and 9.85m high.

- \* Overview of tank ,
- \* Preparation of seams ,
- \* Application of Belzona<sup>®</sup> 1111 ,
- \* Application of Belzona<sup>®</sup> 1321 ,

Works were carried out in accordance with Belzona Know-How System Leaflet TCC-1. The leaking areas were prepared initially by wet slurry blasting, as the potentially explosive oil would not permit gritblasting or grinding. Belzona<sup>®</sup> 1111 was applied followed by Belzona<sup>®</sup> 9341 (Reinforcement Tape). Two coats of Belzona<sup>®</sup> 1321 completed the application.

Belzona repairs allowed tank to be safely re-instated without hot work and proved totally successful until the tank was eventually de-commissioned.
