Belzona solutions offer longevity to containment area

ID: 1603

Industry: *Commercial Facilities*
Application: *TCC-Tanks and Chemical Containment Areas*
Substrate: *Concrete*
Products: ** Belzona 4111 (Magma-Quartz),
* Belzona 4911 (MagmaTX Conditioner),*

Customer Location: *JCB, UK*
Application Date: *2005*

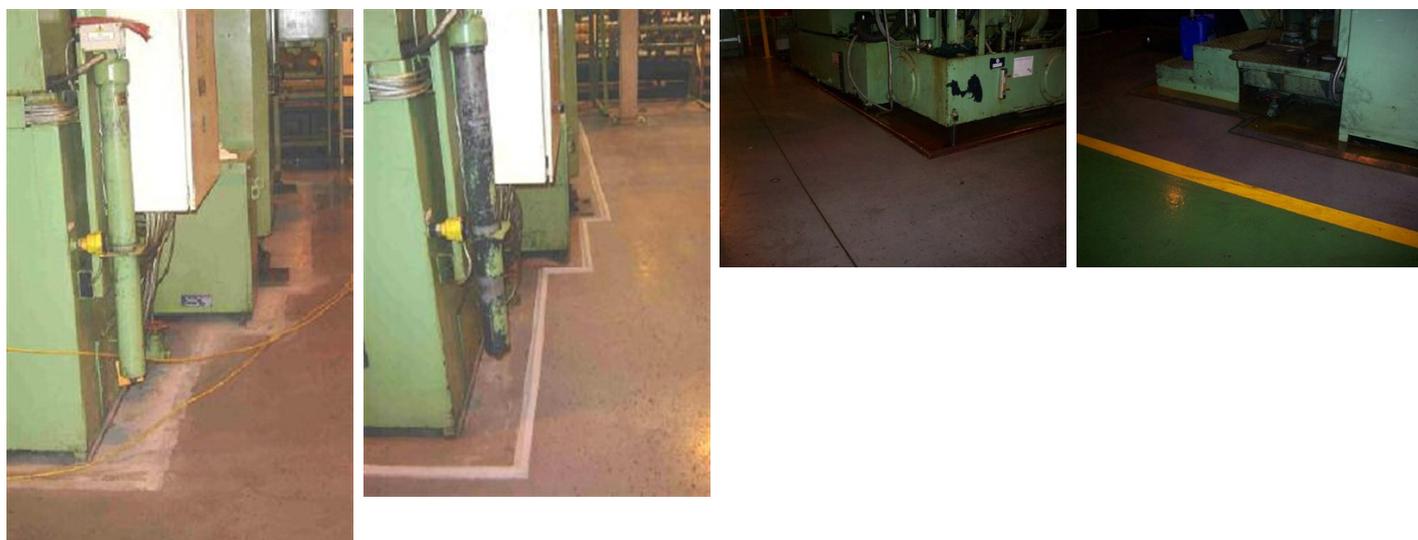
Leaking lubricant oil, cutting fluids, inks or other chemicals from production machinery which seeps/spills/runs across the floor and into pedestrian walkways. This causes environmental as well as safety problems.

- * 1. The problem area. ,
- * 2. Completed application. ,
- * 3. 6 years after application completed. ,
- * 4. Application date back 6 years ultimately proving the longevity of the solution. ,

Created a containment area around the machinery to prevent potential spills from causing a hazardous work area.

Application was carried out in accordance with Belzona Know-How System Leaflets TCC-9&15. Prepared the surface by grinding (with dust extraction) and then marked and coated with Belzona 4911 (MagmaTX Conditioner), cut the pipe in half length ways which are then filled with Belzona 4111 (Magma-Quartz) to create containment trap.

Like all other Belzona applications, it was done with minimal downtime, performed in-situ and cost-effective. It protects the environment and addresses serious safety concerns. The application has been in service for 6 years and still in perfect condition today. The client also commented that he was delighted by the level of service offered by the local team.
