# BELZONA RESTORES HYGEINE IN BOTTLING ROOM

Customer Location: Bottled Water Manufacturer, Perthshire, UK

Application: FPA-Floor Problem Areas

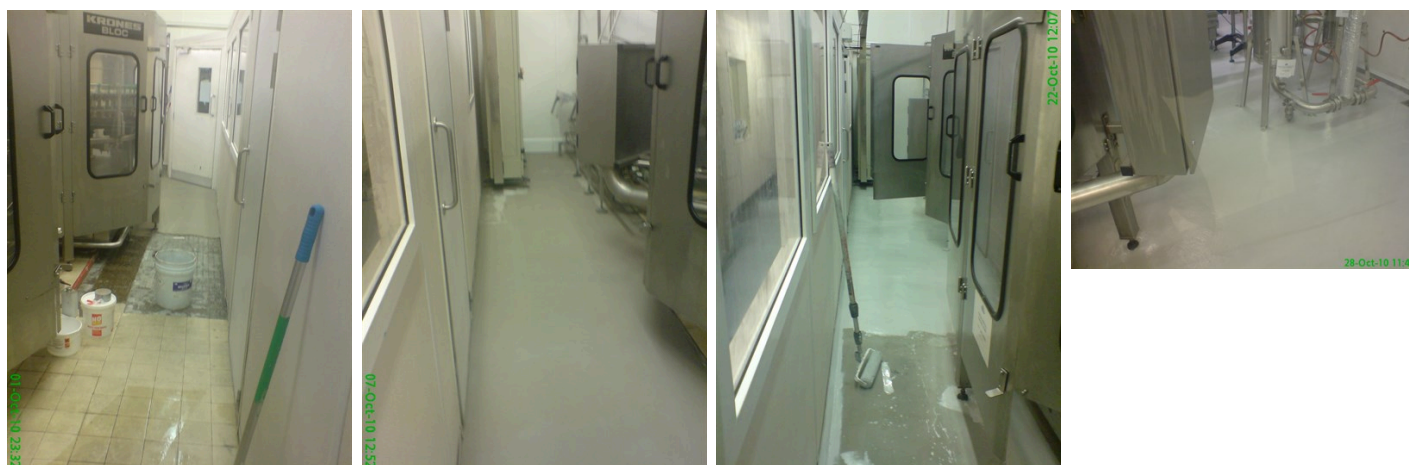
There were several cracked and broken tiles. This created a potential hygiene problem and required rectifying to remove traps for bacteria and to aid cleaning.

- \* Damaged tiles being repaired with Belzona® 4131 ,
- \* Floor levelled with Belzona® 4131 ,
- \* Light grey Belzona® 5231 being applied ,
- \* Completed floor coating ,

Application was carried out in accordance with Belzona Know-How System Leaflets FPA-1 & 3. Belzona® 4131 was used to replace loose tiles and create a uniform surface prior to application of the Belzona® 5231.
