BELZONA REFURBISHMENT MAKES FIRE ESCAPE SAFE

Industry: Buildings & Structures
Application: FPA-Floor Problem Areas
Substrate: Steel

Customer Location: Police Station, UK
Application Date: November 2010

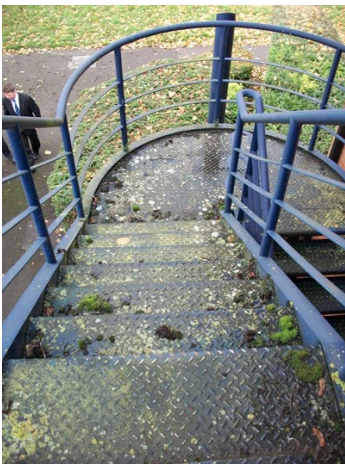
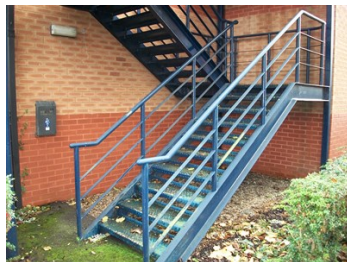
Regular foot traffic and weathering caused the steps of this fire escape to become damaged and worn and had made it a potential slip hazard.

- * Original condition of the entrance steps ,
- * Original condition of the entrance steps ,
- * The finished application ,
- * The finished application ,

Application was carried out in accordance with a modified Belzona Know-How System Leaflet FPA-8. Belzona® 4411 (Granogrip) was applied to the steps with aggregate incorporated in grey and yellow. Belzona® 5111/6111 system applied to the hand rails. Belzona® 1111 was used to smooth out corroded steelwork.
