# BELZONA REFURBISHMENT MAKES FIRE ESCAPE SAFE

ID: 1606

Customer Location: Police Station, UK  
Application Date: November 2010

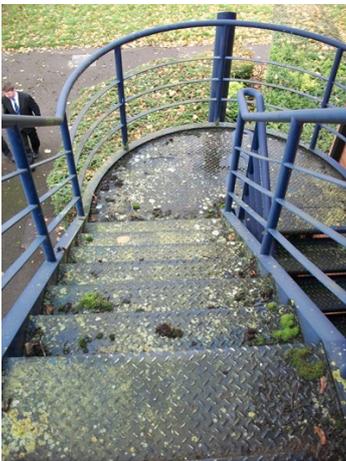
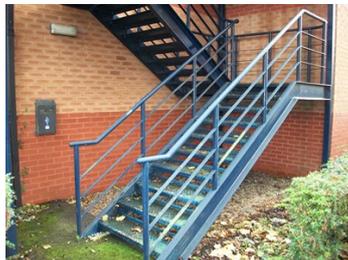
Regular foot traffic and weathering caused the steps of this fire escape to become damaged and worn and had made it a potential slip hazard.

- \* Original condition of the entrance steps ,
- \* Original condition of the entrance steps ,
- \* The finished application ,
- \* The finished application ,

Application was carried out in accordance with a modified Belzona Know-How System Leaflet FPA-8. Belzona® 4411 (Granogrip) was applied to the steps with aggregate incorporated in grey and yellow. Belzona® 5111/6111 system applied to the hand rails. Belzona® 1111 was used to smooth out corroded steelwork.
