BELZONA SEALS TANK AT CABLE MANUFACTURER

Customer Location: Cable manufacturer, US
Application Date: December 2010

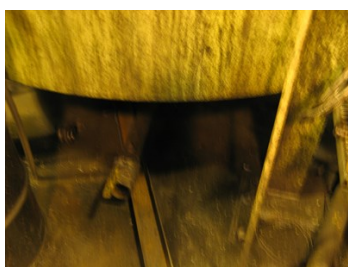
- * Exterior of tank ,
- * Pitted bottom after cleaning and blasting ,
- * Belzona® 1111 seals welds and holes ,
- * First coat of Beige® 5811 applied ,

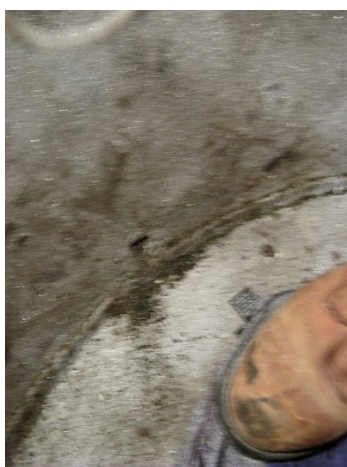
Interior bottom cone of tank was leaking resulting in safety issues. severe corrosion pitting present particularly at the welded seams.
