# BELZONA PROVIDES CORROSION PROTECTION TO HVAC AIR HANDLER

**Industry:** Heating, Ventilation & Air Conditioning  
**Application:** TCC-Tanks and Chemical Containment Areas  
**Substrate:** Carbon Steel  
**Products:** \* Belzona 5811 (Immersion Grade),

**Customer Location:** Ontario, Canada  
**Application Date:** July 2010

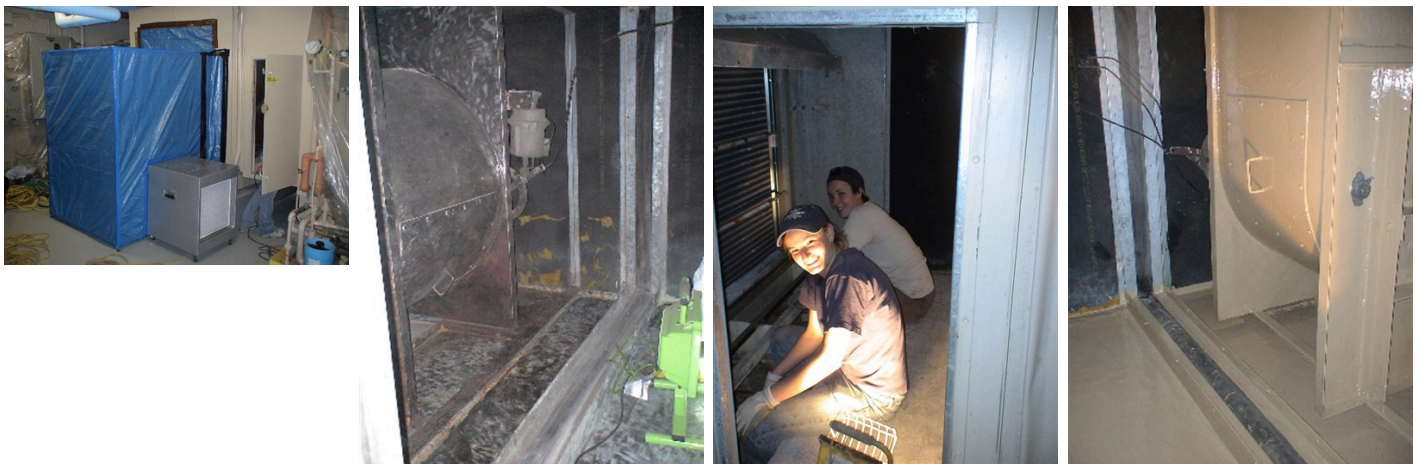
Internal corrosion had led to water leaks and these were finding their way through to the floor below.

- \* Negative pressure system to prevent dust ,
- \* Condition of the air handler internals ,
- \* Work in progress ,
- \* Two Coat Belzona® 5811 System completed ,

Humidification equipment was causing severe corrosion to air handler internal surfaces.

Application was carried out in accordance with Belzona Know-How System Leaflet TCC-5. A filtration system was constructed to prevent dust exiting the air handler.

The Belzona application provides long term corrosion protection at a fraction the cost of having to replace the units. Application was completed with minimal disruption to normal operations in the building.
