BELZONA PROVIDES CORROSION PROTECTION TO HVAC AIR HANDLER

ID: 1609

Industry: Heating, Ventilation & Air Conditioning
Application: TCC-Tanks and Chemical Containment Areas
Substrate: Carbon Steel
Products: * Belzona 5811 (Immersion Grade),

Customer Location: Ontario, Canada
Application Date: July 2010

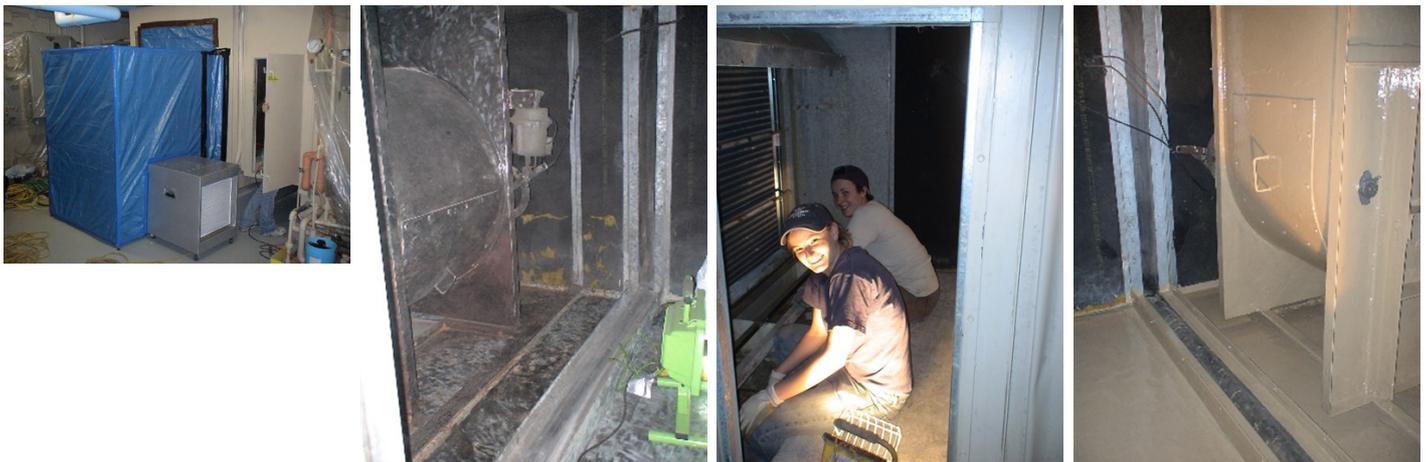
Photograph Descriptions

Internal corrosion had led to water leaks and these were finding their way through to the floor below.

- * Negative pressure system to prevent dust ,
- * Condition of the air handler internals ,
- * Work in progress ,
- * Two Coat Belzona® 5811 System completed ,

Humidification equipment was causing severe corrosion to air handler internal surfaces.

Application was carried out in accordance with Belzona Know-How System Leaflet TCC-5. A filtration system was constructed to prevent dust exiting the air handler.

The Belzona application provides long term corrosion protection at a fraction the cost of having to replace the units. Application was completed with minimal disruption to normal operations in the building.
