# BELZONA PROTECTS LARGE COLLECTION TANK

**Customer Location:** Chemical park, Germany  
**Application Date:** December 2010

Underground collection tank for waste surface water

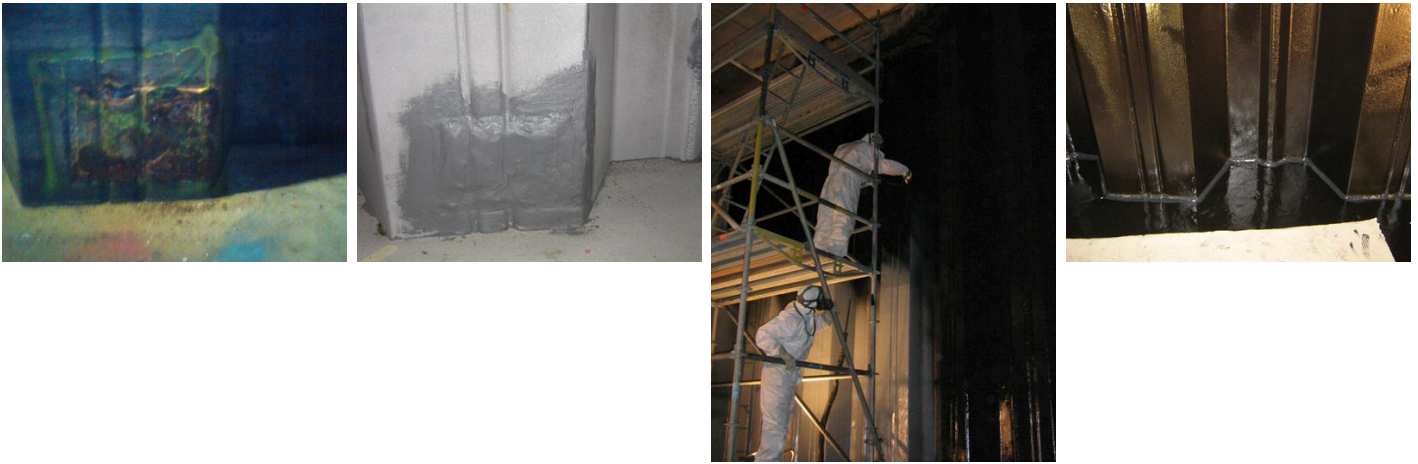
Breakdown of the original coating had allowed corrosion pitting to occur. some leaks were occurring on the walls, particularly where wall meets the concrete tank floor.

- \* Pitting corrosion on tank walls ,
- \* Rebuild and reinforced area with Belzona® 1111 ,
- \* Spray-applied second layer of Belzona® 5811 ,
- \* Completed application ,

Application was carried out in accordance with Belzona Know-How System Leaflets TCC-1, TCC-5 & TCC-9. After surface preparation, Belzona® 1111 was used to bond reinforcement steel sheets to areas affected by pitting corrosion. Belzona® 4111 was used to

repair damaged areas on the concrete tank base. The entire collection tank was coated with Belzona® 5811 applying two coats by airless spray. Lastly, an elastomeric fillet was created by applying Belzona® 2211 where steel walls joined onto the concrete base.
