BELZONA REPLACES FAILED TANK BASE SEAL

ID: 1615

Industry: Chemical & Petrochemical
Application: TCC-Tanks and Chemical Containment Areas

Customer Location: Chemical plant, UK
Application Date: November 2004

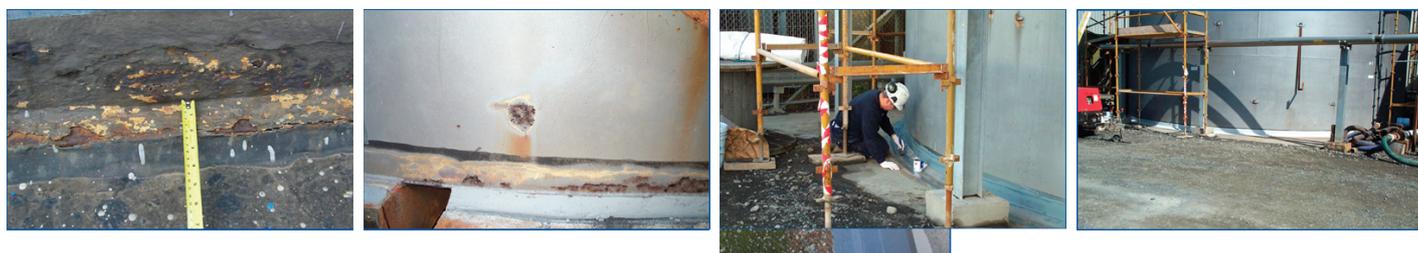
Photograph Descriptions

Original seal had cracked and allowed moisture to penetrate beneath tank base. Problem exacerbated by poor water shed leading to external corrosion.

- * Close up showing failure of original seal. ,
- * Fillet of Belzona® 4131 applied ,
- * Application of Belzona 3111® System underway. ,
- * Application completed. ,

Traditional sealing materials had failed due to lack of flexibility. Improved water shed created by applying fillet of Belzona® 4131. Belzona® 3111 has a proven track record in waterproofing tank bases.
