# BELZONA® 2211 SAVES EXPANSION JOINTS AT NEW AIRPORT

ID: 162

**Customer Location:** New Metropolitan Airport  
**Application Date:** October 1995

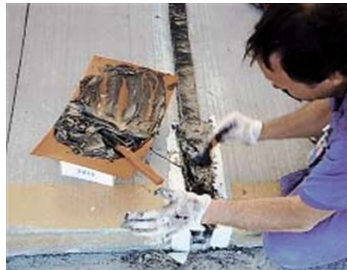
Outdoor expansion joints created hazards for people and equipment at the main loading and unloading gates.

\* Backer rod with previous failed product pulled from joint, notice substrate chunks attached to failed product Close to the end of filling the joint The cured section, ready for service ,

The application was carried out in accordance with Belzona Know-How Leaflets FPA-5 and FPA-6.

Only Belzona® 2211 had the proper combination of hardness, elasticity, adhesive strength, and paste grade application control. A long shelf life allows the customer to purchase larger quantities with confidence and lets them continue repairs with products from stock as time permits.
