BELZONA® 2211 SAVES EXPANSION JOINTS AT NEW AIRPORT

ID: 162

Customer Location: New Metropolitan Airport
Application Date: October 1995

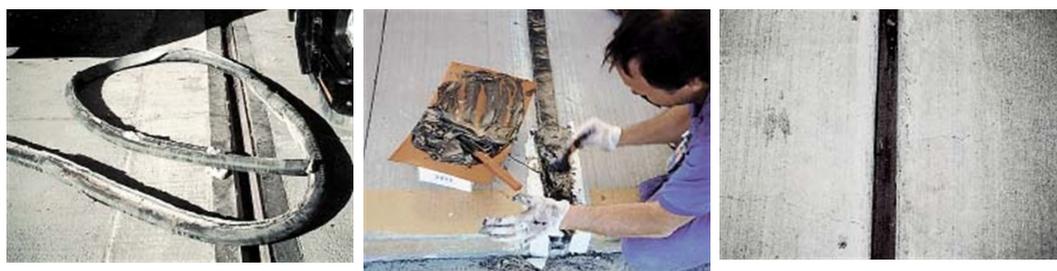
Photograph Descriptions

Outdoor expansion joints created hazards for people and equipment at the main loading and unloading gates.

* Backer rod with previous failed product pulled from joint, notice substrate chunks attached to failed product Close to the end of filling the joint. The cured section, ready for service ,

The application was carried out in accordance with Belzona Know-How Leaflets FPA-5 and FPA-6.

Only Belzona® 2211 had the proper combination of hardness, elasticity, adhesive strength, and paste grade application control. A long shelf life allows the customer to purchase larger quantities with confidence and lets them continue repairs with products from stock as time permits.
