BELZONA PROTECTS SUGAR BEET MIXER SHAFT

ID: 1623

Customer Location: *Sugar beet factory, Switzerland*
Application Date: *2010*

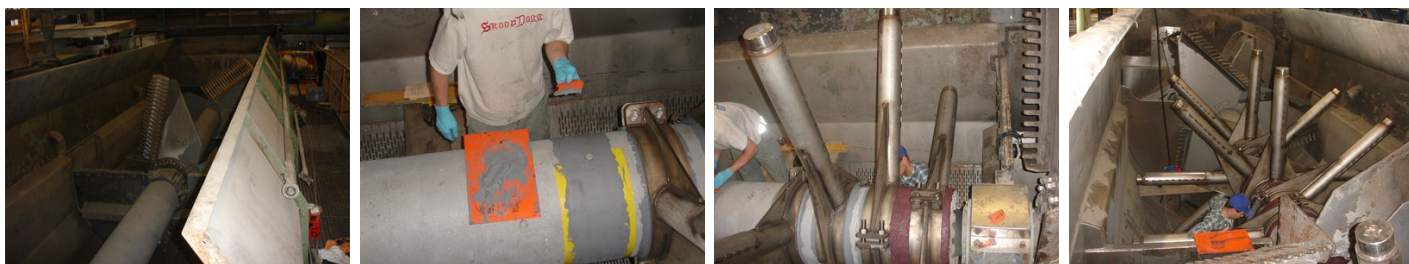
Photograph Descriptions

Loose particles of soil and small pieces of rock, released during the processing of the sugar beet causes abrasion on the shaft.

- * Shaft after removal of half shells and agitating arms ,
- * Application of Belzona® 1121 ,
- * Application of Belzona® 1811 ,
- * Completed shaft with agitating arms screwed back in place ,

Application was carried out in accordance with Belzona Know-How System Leaflets GSS-9 and SHM-14. Belzona® 1121 was used to create irregular shims under the half shells to ensure perfect fit onto the shaft. The exposed areas of shaft were protected with Belzona® 1811 against future abrasion damage.
