BELZONA SEALS HEAT EXCHANGER AT METHANOL PLANT

Industry: *Chemical & Petrochemical*
Application: *HEX-Heat Exchangers*
Substrate: *Carbon steel*
Products: ** Belzona® 1511 (Super HT Metal) ,*

Customer Location: *Chemical plant, Iran*
Application Date: *December 2010*

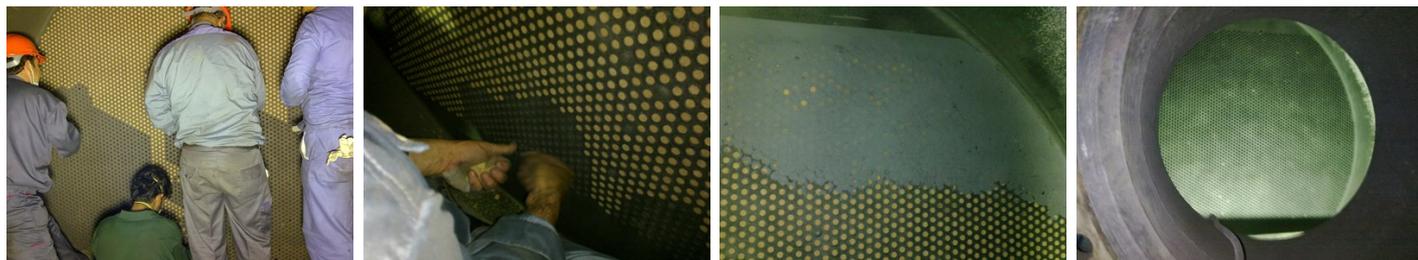
Photograph Descriptions

There was a lot of leakage between tubes and sheet due to galvanic corrosion.

- * Workers corking the tubes ,
- * Close up ,
- * Tube sheet face rebuilt with Belzona® 1511 ,
- * Completed application after removal of corks ,

The high heat resistance of Belzona® 1511 ensured long term adhesion to the hot substrate. The Belzona repair saved both time and costs over the alternative of welding or re-tubing.
