# BELZONA SEALS HEAT EXCHANGER AT METHANOL PLANT

Industry: *Chemical & Petrochemical*  
Application: *HEX-Heat Exchangers*  
Substrate: *Carbon steel*  
Products: *\* Belzona® 1511 (Super HT Metal) ,*

Customer Location: *Chemical plant, Iran*  
Application Date: *December 2010*

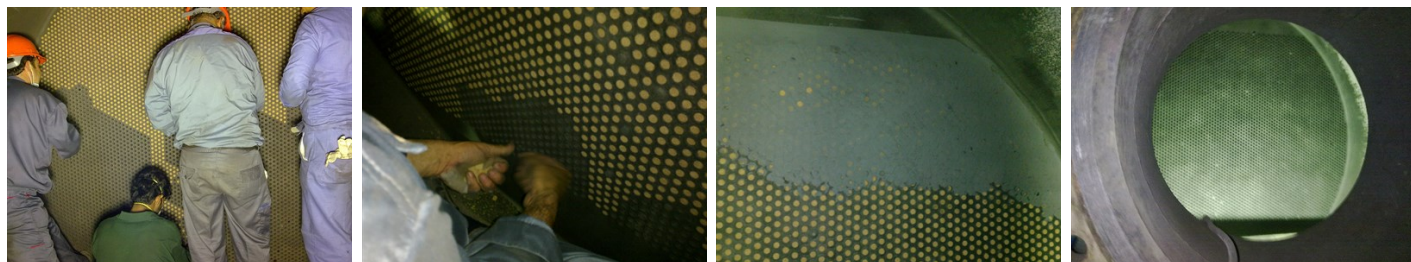
*There was a lot of leakage between tubes and sheet due to galvanic corrosion.*

- \* Workers corking the tubes ,
- \* Close up ,
- \* Tube sheet face rebuilt with Belzona® 1511 ,
- \* Completed application after removal of corks ,

The high heat resistance of Belzona® 1511 ensured long term adhesion to the hot substrate. The Belzona repair saved both time and costs over the alternative of welding or re-tubing.
