BELZONA KEEPS COURT IN SESSION

ID: 1631

Customer Location: Courthouse, Minneapolis, MN
Application Date: June 2008

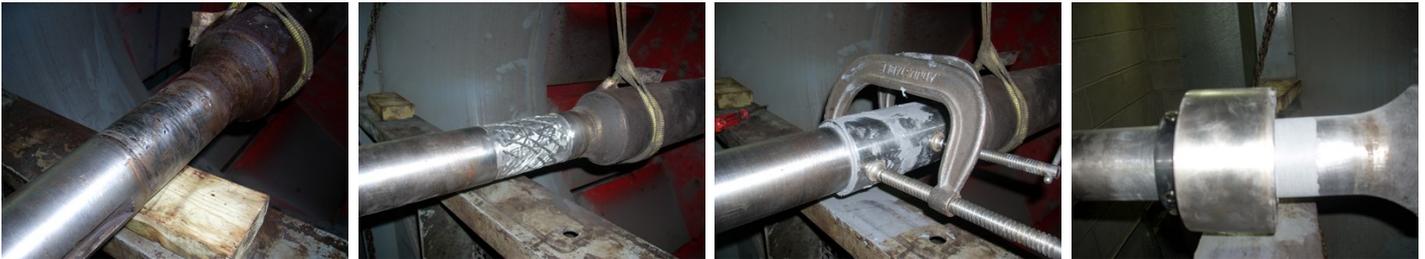
Photograph Descriptions

Bearing had failed scoring the 2 1/2 inch shaft. Hot weather required air conditioning to be working effectively.

- * Scored shaft ,
- * Surface preparation ,
- * Belzona applied and former secured after treating with Belzona Release Agent ,
- * Finished shaft with bearing reinstalled ,

Application was carried out in accordance with Belzona Know-How System Leaflets FBC-13

Former was able to be made in one day. Belzona application was completed the next day and fan was back operating that night. Traditional repairs would have taken up to two weeks with cost of man hours and new shaft far exceeding cost of the Belzona repair.
