BELZONA PROTECTS WET CYLINDER LINERS ON DIESEL ENGINE

Industry: Power
Application: ENC-Engines and Casings
Substrate: Cast iron
Products: * Belzona® 1311 (Ceramic R Metal) ,
* Belzona® 1391 (Ceramic HT) ,

Customer Location: Small Power Utilities Group, Philippines
Application Date: August, 2010

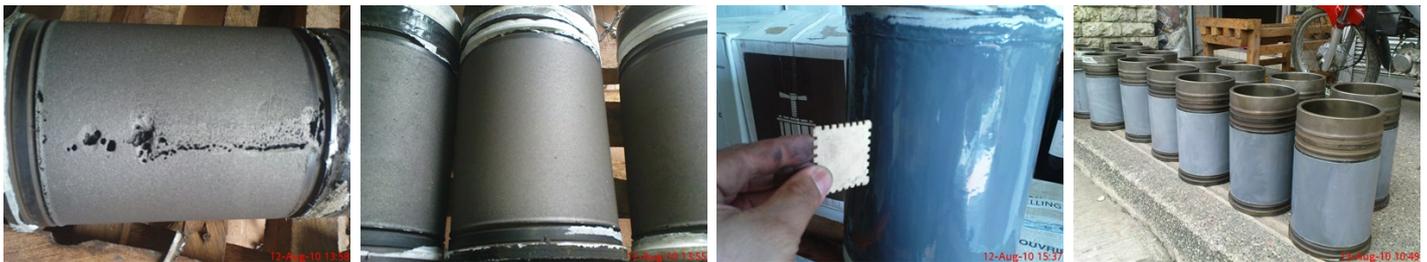
Photograph Descriptions

Erosion corrosion pitting on liner bodies.

- * Pitting on the body of the wet cylinder liners ,
- * Cylinder liner after grit blasting ,
- * Checking the application thickness ,
- * Some of the 24 units repaired and protected with Belzona ,

The application was carried out in accordance with Belzona System Leaflet ENC-6. Pitting was filled with Belzona® 1311 before providing overall erosion corrosion protection with Belzona® 1391 coating.

Unavailability of replacement parts was remedied by the use of Belzona which will extend the service life of the liners.
