FOUR BELZONA REPAIRED CONDENSERS STILL IN SERVICE AFTER 17 YEARS

Customer Location: *Power station, Thailand*
 Application Date: *October 1993*

Four main condensers with a total of eight tube sheets

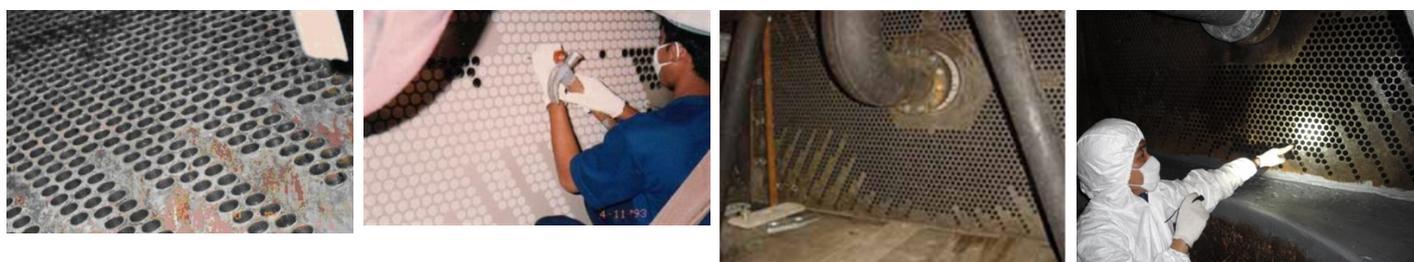
Corrosion pitting had occurred around the tubes as a result of bi-metallic corrosion effects and the chloride content of the used river water.

- * Corroded tube sheet before application in 1993 ,
- * Standard application underway. Special care was taken to prevent contamination of substrate) ,
- * Inspection in 2005 ,
- * Inspection in 2010 ,

The application was carried out in accordance with the Belzona Know-How System Leaflet HEX-1. Belzona® 1311 was used for rebuilding and Belzona® 1321 for the coating of the tube sheets.

Since the application of the coating, regular inspections took place which proved the excellent performance of the Belzona coating. In 2005, the complete coating of the tube sheet was still intact without showing any signs of degradation. A further inspection in 2010, after 17 years in service, also showed that the coating was still in a good condition. Only 10% of the surface was locally

damaged due to mechanical damage. These areas were quickly repaired with Belzona before the tube sheet was put back into service.
