FOUR BELZONA REPAIRED CONDENSERS STILL IN SERVICE AFTER 17 YEARS

Customer Location: Power station, Thailand

Four main condensers with a total of eight tube sheets

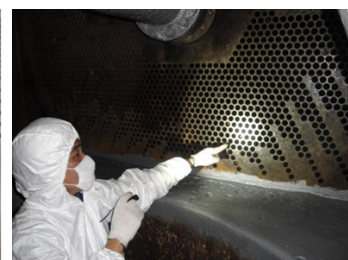
Corrosion pitting had occurred around the tubes as a result of bi-metallic corrosion effects and the chloride content of the used river water.

- * Corroded tube sheet before application in 1993 ,
- * Standard application underway. Special care was taken to prevent contamination of substrate) ,
- * Inspection in 2005 ,
- * Inspection in 2010 ,

The application was carried out in accordance with the Belzona Know-How System Leaflet HEX-1. Belzona® 1311 was used for rebuilding and Belzona® 1321 for the coating of the tube sheets.

Since the application of the coating, regular inspections took place which proved the excellent performance of the Belzona coating. In 2005, the complete coating of the tube sheet was still intact without showing any signs of degradation. A further inspection in 2010, after 17 years in service, also showed that the coating was still in a good condition. Only 10% of the surface was locally

damaged due to mechanical damage. These areas were quickly repaired with Belzona before the tube sheet was put back into service.
