# BELZONA KEEPS MANUFACTURER COOL

ID: 1638

Cooling tower at this major manufacturer of Aluminium castings for the motor industry

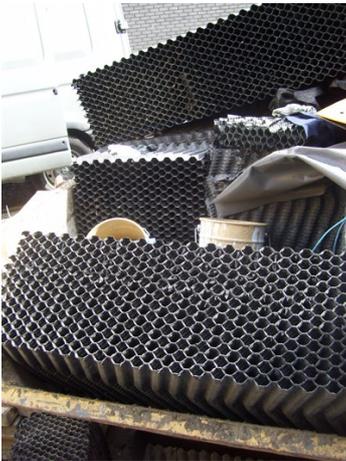
Dosing chemicals designed to control algae growth had led to severe corrosion throughout the cooling tower, with holes occurring in places.

- \* Packing removed ,
- \* Tented up and ready for application ,
- \* Completed application ,
- \* Floor area completely protected with Belzona<sup>®</sup> 5811 ,

Application was carried out in accordance with Belzona Know-How System Leaflets TCC-1 & TCC-5. After removing roof and removing all the packing (used to increase surface area), Belzona<sup>®</sup> 1111 was used to bond doubler plates over holed/thinned areas before the entire surface was protected with Belzona<sup>®</sup> 5811.
