BELZONA KEEPS MANUFACTURER COOL

Customer Location: Aluminium Casting Manufacturer, N. Ireland

Application: CEP-Centrifugal Pumps

Cooling tower at this major manufacturer of Aluminium castings for the motor industry

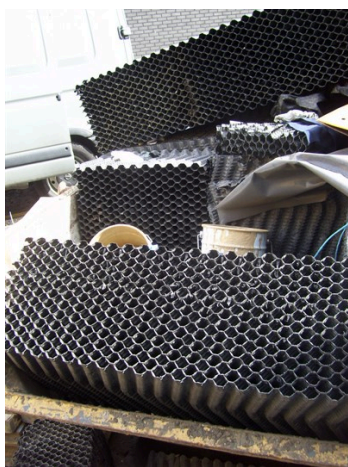
Dosing chemicals designed to control algae growth had led to severe corrosion throughout the cooling tower, with holes occurring in places.

- * Packing removed ,
- * Tented up and ready for application ,
- * Completed application ,
- * Floor area completely protected with Belzona[®] 5811 ,

Application was carried out in accordance with Belzona Know-How System Leaflets TCC-1 & TCC-5. After removing roof and removing all the packing (used to increase surface area), Belzona[®] 1111 was used to bond doubler plates over holed/thinned areas before the entire surface was protected with Belzona[®] 5811.
