# BELZONA, THE EASY WAY TO SEAL SILOS

ID: 1639

## Application Situation

Two 17 metre high, 6 metre diameter silos for storage of Lime and Chalk

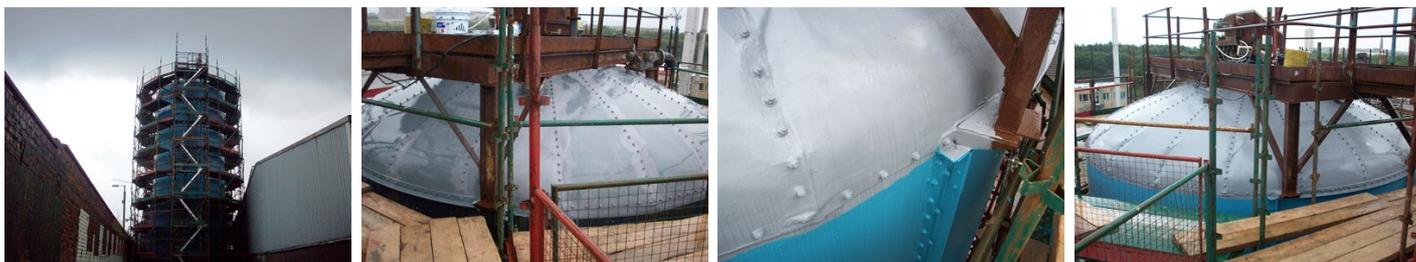
## Photograph Descriptions

*Corrosion and mechanical damage had opened up the bolted joints allowing rain water to wash dirt through the joints leading to contamination of the lime and chalk stored in the silos.*

- \* Silo scaffolded and ready for work to commence ,
- \* Initial application to problem areas ,
- \* Silo roof fully protected ,
- \* Completed application ,

Application was carried out in accordance with Belzona Know-How System Leaflet RPA-1. After preparing substrate with grinders, Belzona® 3921 (GSC Conditioner) was applied before completing the application with two coats Belzona® 3111.
