BELZONA REVISITS LEAKING PIPE

ID: 1640

Customer Location: Power Station, Wales
 Application Date: February 2008

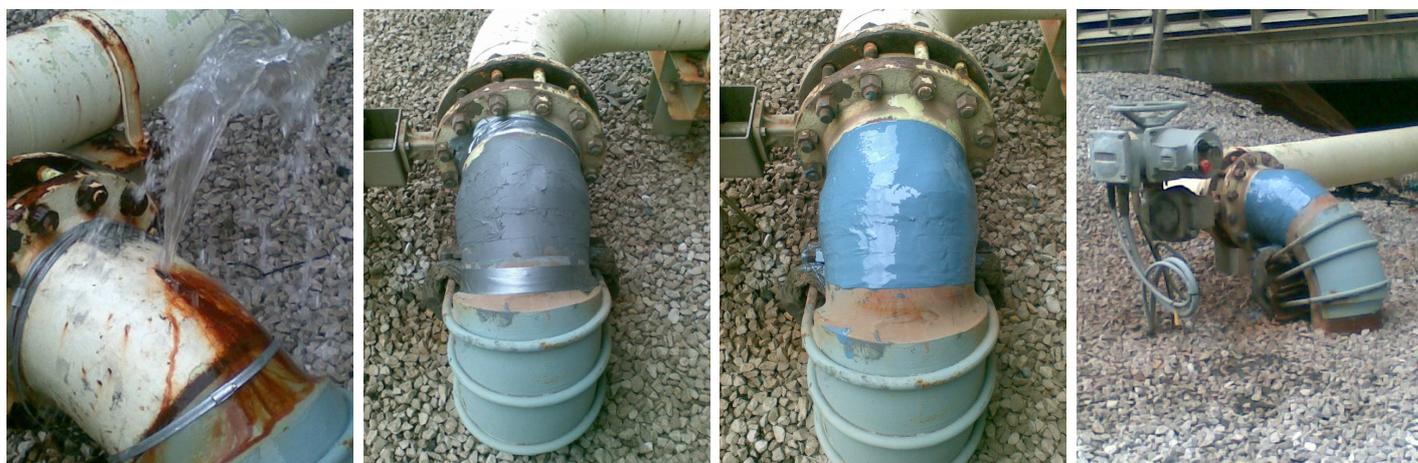
Photograph Descriptions

Leaking pipe was affecting efficiency of the cooling system. Back pressure meant repair had to be carried out live and to a very tight schedule. Adjacent section of pipe had previously been repaired with Belzona.

* The leak Belzona® 1111 wrap completed Completed application protected with Belzona® 1341 Note earlier repair immediately below latest repair ,

Application was carried out in accordance with Belzona Know-How System Leaflet VPF-11a. After temporarily stemming leak with Belzona® 1291, Belzona® 1221 was applied to give additional strength before grit blasting and applying a Belzona® 1111 wrap. Belzona® 1341 was applied over the top to provide corrosion protection to exposed section of pipe.

Just 2 hours after vcompleting the repair, the full pressure was restored. This repair has now been in service 3 years with the

earlier repair now 7 years in service.
