BELZONA HELPS KEEP THE FARMS FREE FROM FLOODING

ID: 1641

Customer Location: Water Authority, UK
Application Date: October 2008

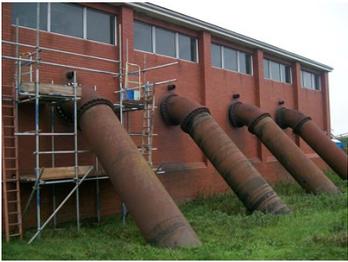
- * General view of the pumping station with the 4 outlet pipes ,
- * The damaged pipe ,
- * Belzona[®] 1291 applied to stem leak ,
- * Pipe completely wrapped with Belzona 1161 ,

Pumping station used to regulate the water table in the surrounding low lying farmland. There are 4 pump sets that transfer water from the land into the nearby river to prevent flooding.

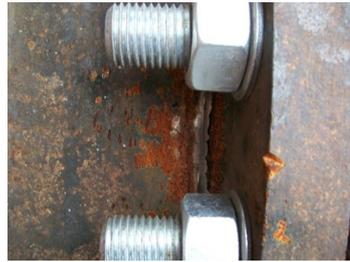
Crack on one of the 900mm outlet pipes was jeopardising operation of the pump set. Due to the time of year and high risk of flooding it was deemed unacceptable to take the set offline and carry out a conventional repair.

A weld repair had already been tried and failed. The Belzona repair allowed flood defences to continue until flood risk was lower and pipe could be dug out and replaced.
