# BELZONA REPAIRS ROOF AT PRESTIGIOUS UNIVERSITY

Application: *RPA-Roof Problem Areas*

Customer Location: *University Library, UK*

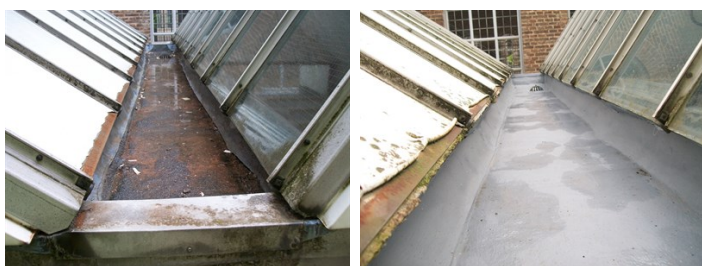
## Photograph Descriptions

- \* Damaged gutter prior to the application ,
- \* Gutter coated with Belzona® 3111 ,
- \* Leaking roof area ,
- \* Roof coated with Belzona® 3111 ,

The mineral felt roof and gutters were in poor condition with various areas leaking directly into the reading room below where many historic books are stored and read daily by students.

Application was carried out in accordance with Belzona Know-How System Leaflets RPA-1, 6 & 8.

The University had experienced problems before with students complaining about the smell and feeling ill due to competitors solvent-based roofing products being used on other University buildings. Belzona® 3111 fully reinforced system was applied without disruption to the daily use of the library reading rooms below.
