BELZONA SEALS ROOFTOP EXPANSION JOINTS

ID: 1648

Application: RPA-Roof Problem Areas

Customer Location: University, Leeds, UK

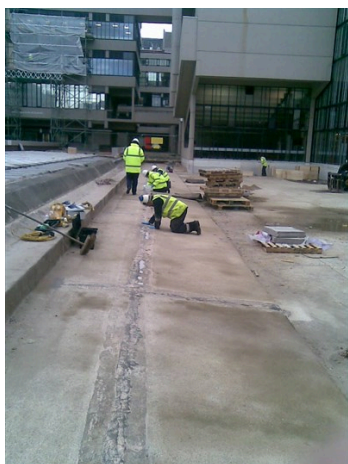
Pond had been drained for refurbishment and concern was expressed over the waterproofing of the expansion joints.

- * Roof showing signs of damage ,
- * Close up of the damage ,
- * Application in progress ,
- * The application completed ,
