# BELZONA KEEPS ICE CREAM FLOWING

Industry:	General Industry	Customer Location:	Dairy for local Supermarket Chain in Missouri
Application:	GSS-Gaskets, Seals and Shims	Application Date:	August 1995
Substrate:	Stainless steel		
Products:	* Belzona® 2221 (MP Fluid Elastomer) ,

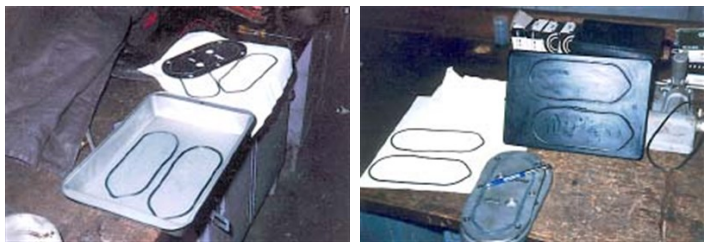
Worn gaskets

- \* New gaskets glued to a cookie tin to create a mold; Belzona® 9411 (Release Agent) was used in the molding process. ,
- \* View of the mold, the plate, and the new gaskets casted from the mold. ,

The application was carried out in accordance with Belzona Know-How Leaflet GSS-1.

The manufacturer of the plates would not supply the gaskets separately. The gaskets could only be obtained by purchasing new plates at a cost of \$400 each. The dairy had eight plates (worth over \$3,200) out of service, requiring gaskets immediately, plus eight more in service that would soon require new gaskets. By using Belzona, the customer saved several thousand dollars in replacement parts and kept the ice cream flowing.
