BELZONA REPAIRS SUN DAMAGE ON ROOF

Customer Location: Railway Engineering Workshops in Northern England

Application: RPA-Roof Problem Areas

Substrate: Concrete treated with bitumen

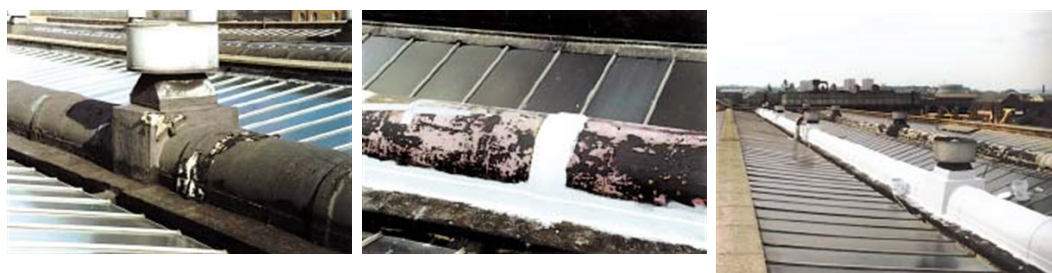
Photograph Descriptions

Leaks at seams, bituminous coating is damaged

- * Failed bituminous coating ,
- * Seam areas addressed ,
- * Ducting completely protected and sealed ,

The tar was severely damaged due to the effects of the sun; further application of the bituminous coating would have also failed. Belzona® 3111 (Flexible Membrane) solved the problem on the roof.

The application was carried out in accordance with Belzona Know-How Leaflet RPA-1.
