# BELZONA REPAIRS SUN DAMAGE ON ROOF

ID: 168

**Customer Location:** *Railway Engineering Workshops in Northern England*

**Application:** *RPA-Roof Problem Areas*

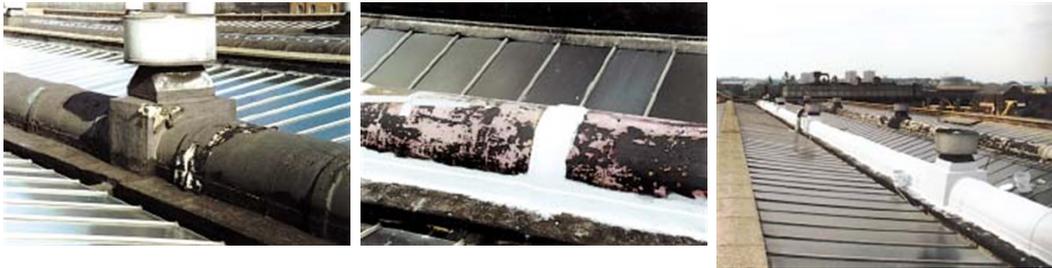
*Leaks at seams, bituminous coating is damaged*

- \* Failed bituminous coating ,
- \* Seam areas addressed ,
- \* Ducting completely protected and sealed ,

The application was carried out in accordance with Belzona Know-How Leaflet RPA-1.

The tar was severely damaged due to the effects of the sun; further application of the bituminous coating would have also failed. Belzona® 3111 (Flexible Membrane) solved the problem on the roof.
