# BELZONA REPAIRS SCHOOL WALKWAY

Industry: Buildings & Structures  
Application: FPA-Floor Problem Areas  
Substrate: Concrete  
Products: \* Belzona® 4131 (Magma Screed) Belzona® 4141 (Magna Build) Belzona® 5151 (Hi Build Cladding) Belzona® 5231 (SG Laminate),

Customer Location: Regional Council Primary School, UK  
Application Date: 2002

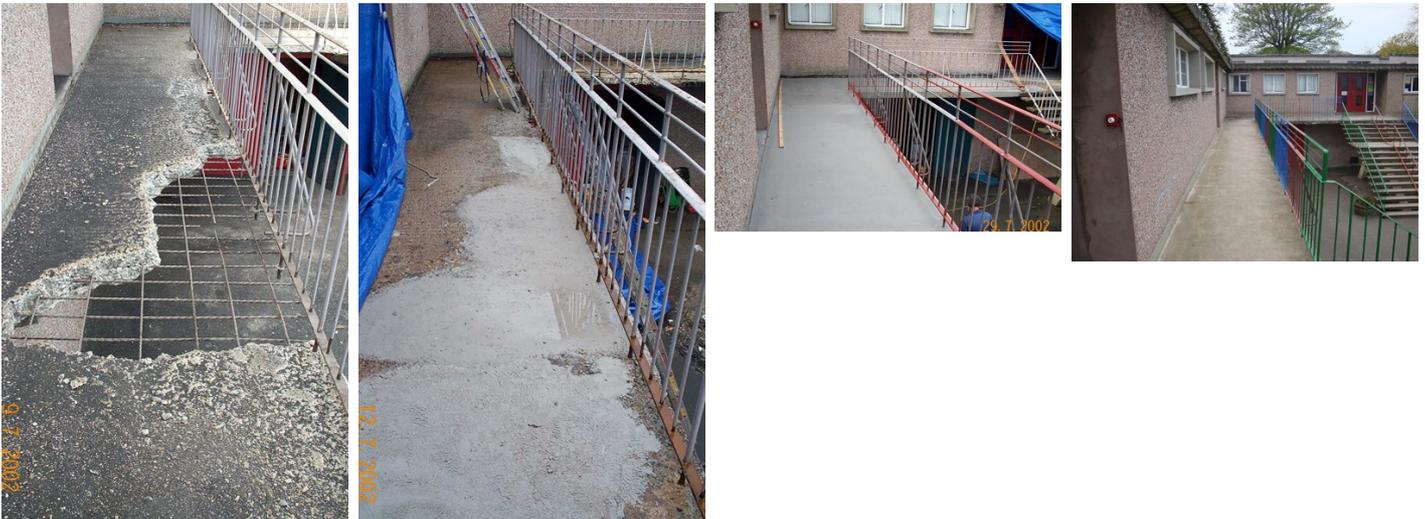
Regular application of salt had led to deterioration of the concrete beneath the asphalt. When asphalt was removed, a major structural issue was uncovered. The structural engineers at the council gave the approval for the repair.

\* Severity of damage revealed after grit blasting. Application of Belzona® 4131 complete. Application of Belzona® 5231 to entire walkway. View of application after 9 years.

Application was carried out in accordance with Belzona® Know How System Leaflet FPA-1.

minimum. Recent (2011) examination showed application to still be in excellent condition.
