# BELZONA REFURBISHES THE FLOORS

ID: 169

Customer Location: Airport Food Service in Missouri  
Application Date: February 1996

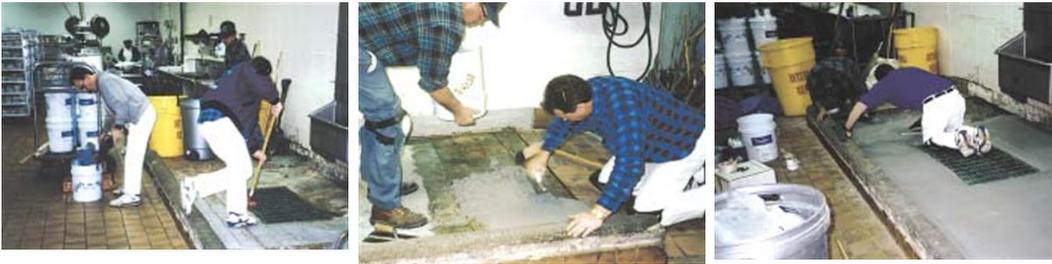
Water was trapped under the tile, causing the tile to break up and providing a haven for bacteria and mold. Pushing the carts over rough, broken, and missing tile posed a serious safety hazard as well.

- \* Removing old tile, dirt and concrete ,
- \* Beginning application of Belzona® 4131 (Magma Screed) ,
- \* Job almost completed ,

Old concrete was removed and 1 1/2" voids were left in several areas. Belzona® 4131 (Magma Screed) was applied over the areas where the minimum depth was 3/8". The application was carried out in accordance with Belzona Know-How Leaflet FPA-1.

The application covered a 72 square foot area and took only two hours to complete. The wash area is now a safer and cleaner place to work.
