BELZONA KEEPS THE BEER BREWING

ID: 170

Industry: *General Industry*
Application: *TCC-Tanks and Chemical Containment Areas*
Substrate: *Concrete*
Products: ** Belzona® 4311 (Magma CR-1),*

Customer Location: *Brewery in Texas*
Application Date: *March 1995*

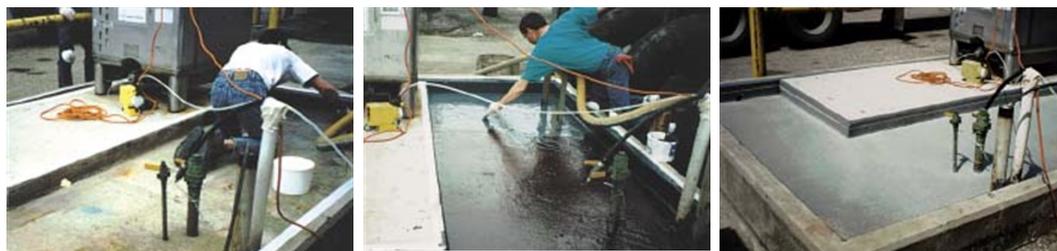
Photograph Descriptions

A chemical containment area was leaking chemicals around the perimeter of the area.

- * Work begins early in the day. ,
- * Following application of the Belzona® 4911 primer coat, the first coat of Belzona® 4311, red, was applied. Application of the second gray coat is in progress. ,
- * The finished Belzona® 4311 protective coating is now ready for service. ,

The application was carried out in accordance with Belzona Know-How Leaflet TCC-15.

Costly environmental regulatory fines were averted by using Belzona. The chemicals were contained and the dike was protected.
