# BELZONA SEALS TRANSFORMER BUNDING

ID: 1706

Customer Location: Electrical power company, Sweden  
Application Date: August 2010

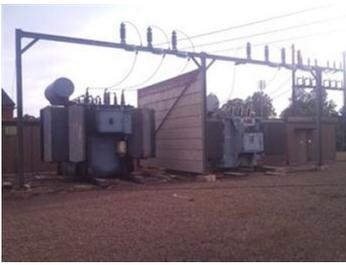
- \* Transformer sub-station in central Sweden ,
- \* Diagram of the secondary containment under the transformer. Note the glands and end plugs ,
- \* Leaking gland ,
- \* All penetrations were sealed with Belzona® 2141 ,

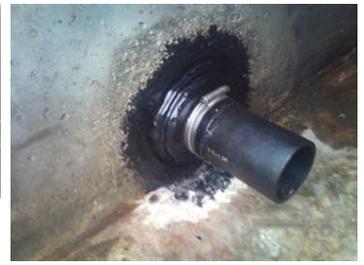
The bunding for oil-filled transformers was made up of many interconnected small concrete bunds. Connection to each bund was through polyethylene pipes. These pipe penetrations were sealed with rubber sleeves. The outer walls had polyurethane foam inserts. The glands and end-plugs were leaking since the concrete bunds were moving independently of each other. There were 32 penetrations in total with 62 sealing points on either side of the penetrations. The power company decided to seal all the pipe penetrations. The 18 end plugs in the outer wall were also replaced with Belzona.

Application was carried out in accordance with modified versions of Belzona Know-How System Leaflets GSS-4 and TCC-15. Belzona® 2141 was used to seal each side of the pipe penetrations and Belzona® 4111 was used to replace the end caps in the perimeter wall.
