BELZONA SEALS TRANSFORMER BUNDING

ID: 1706

Customer Location: Electrical power company, Sweden
Application Date: August 2010

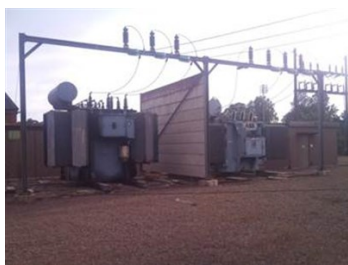
The bunding for oil-filled transformers was made up of many interconnected small concrete bunds. Connection to each bund was through polyethylene pipes. These pipe penetrations were sealed with rubber sleeves. The outer walls had polyurethane foam inserts. The glands and end-plugs were leaking since the concrete bunds were moving independently of each other. There were 32 penetrations in total with 62 sealing points on either side of the penetrations. The power company decided to seal all the pipe penetrations. The 18 end plugs in the outer wall were also replaced with Belzona.

- * Transformer sub-station in central Sweden ,
- * Diagram of the secondary containment under the transformer. Note the glands and end plugs ,
- * Leaking gland ,
- * All penetrations were sealed with Belzona® 2141 ,

Application was carried out in accordance with modified versions of Belzona Know-How System Leaflets GSS-4 and TCC-15. Belzona® 2141 was used to seal each side of the pipe penetrations and Belzona® 4111 was used to replace the end caps in the perimeter wall.
