# BELZONA SEALS TRANSFORMER BUNDING

Industry: Power  
Application: GSS-Gaskets, Seals and Shims  
Substrate: Concrete and polyethylene  
Products: \* Belzona® 4111 (Magma Quartz),  
\* Belzona® 2141 (ACR-Fluid Elastomer),

Customer Location: Electrical power company, Sweden  
Application Date: August 2010

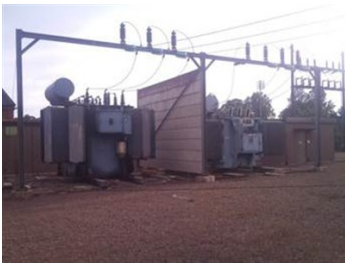
The bunding for oil-filled transformers was made up of many interconnected small concrete bunds. Connection to each bund was through polyethylene pipes. These pipe penetrations were sealed with rubber sleeves. The outer walls had polyurethane foam inserts. The glands and end-plugs were leaking since the concrete bunds were moving independently of each other. There were 32 penetrations in total with 62 sealing points on either side of the penetrations. The power company decided to seal all the pipe penetrations. The 18 end plugs in the outer wall were also replaced with Belzona.

- \* Transformer sub-station in central Sweden ,
- \* Diagram of the secondary containment under the transformer. Note the glands and end plugs ,
- \* Leaking gland ,
- \* All penetrations were sealed with Belzona® 2141 ,

Application was carried out in accordance with modified versions of Belzona Know-How System Leaflets GSS-4 and TCC-15. Belzona® 2141 was used to seal each side of the pipe penetrations and Belzona® 4111 was used to replace the end caps in the perimeter wall.
