CHIMNEY SHINES WITH BELZONA PROTECTION

ID: 1717

Customer Location: Powerstation, Poland
 Application Date: September, 2008

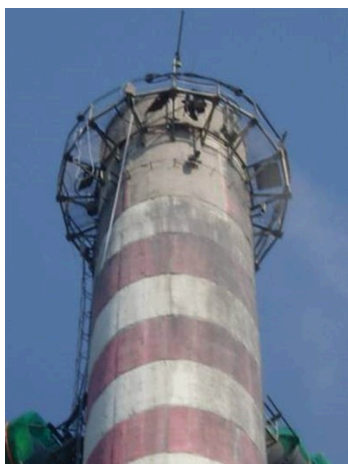
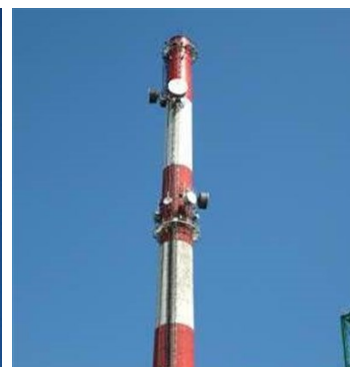
Photograph Descriptions

The existing coating systems had reached the end of their life and broken down resulting in an unattractive and poorly protected chimney stack. The client undertook a comparison of Belzona with a competitor.

- * September 2008 pre works ,
- * Application underway via rope access ,
- * Completed application ,
- * The top two, shiny bands are Belzona® 5111 ,
- * Review in 2010 - note the top two bands are still shiny ,

Application was carried out in accordance with a modified Belzona Know-How System Leaflet WPA-2. Rope Access Technicians were used in place of industrial scaffolding. The top two, most aggressively attacked bands were coated using Belzona® 5111 in red and white.

After initial review it was noted that the Belzona® 5111 quite literally outshone the competition. Aside from the chemical and UV resistance needed for the application, the smooth surface of Belzona® 5111 did not attract dirt and would "self clean" with rain.
