# CHIMNEY SHINES WITH BELZONA PROTECTION

Industry: Power  
 Application: WPA-Wall Problem Areas  
 Substrate: Concrete  
 Products: \* Belzona® 5111 (Ceramic Cladding),

Customer Location: Powerstation, Poland  
 Application Date: September, 2008

120m high Powerstation chimney

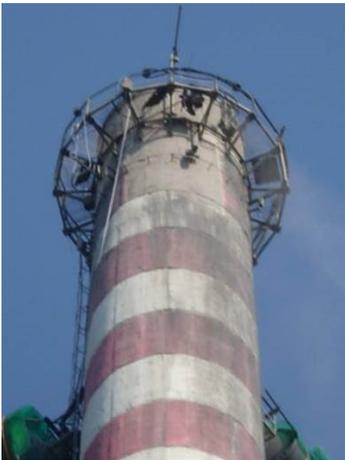
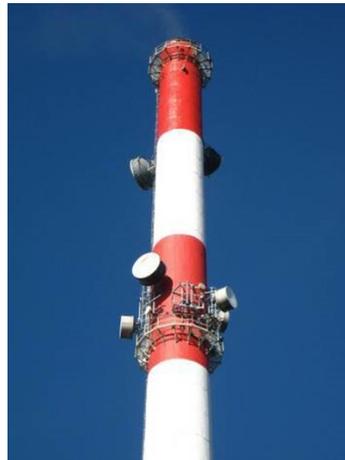
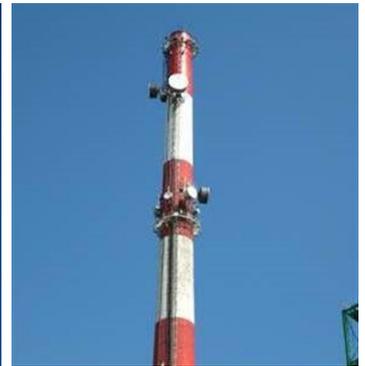
The existing coating systems had reached the end of their life and broken down resulting in an unattractive and poorly protected chimney stack. The client undertook a comparison of Belzona with a competitor.

- \* September 2008 pre works ,
- \* Application underway via rope access ,
- \* Completed application ,
- \* The top two, shiny bands are Belzona® 5111 ,
- \* Review in 2010 - note the top two bands are still shiny ,

Application was carried out in accordance with a modified Belzona Know-How System Leaflet WPA-2. Rope Access Technicians were used in place of industrial scaffolding. The top two, most aggressively attacked bands were coated using Belzona® 5111 in red and white.

After initial review it was noted that the Belzona® 5111 quite literally outshone the competition. Aside from the chemical and UV resistance needed for the application, the smooth surface of Belzona® 5111 did not attract dirt and would "self clean" with rain.
